Manhole Inspection Summary

Manhole # S15K__003MH

Insp Date: **4/2/08 9:11 AM**

Location Address: **123 s franklintown rd**

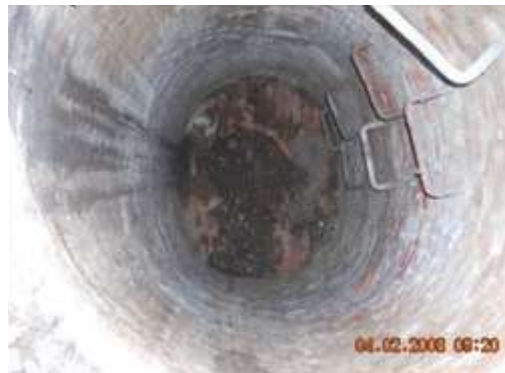
Top View

Count: **7** Missing: **0** ☒ **Corroded**

corroded steps

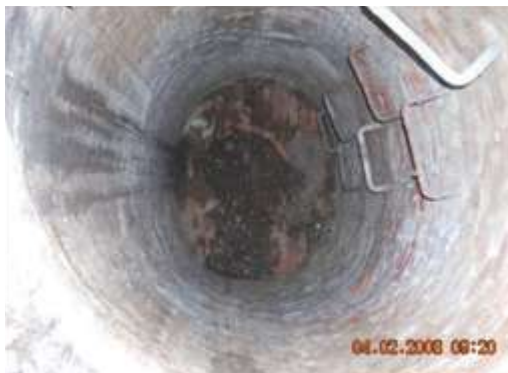
misc

channel debris

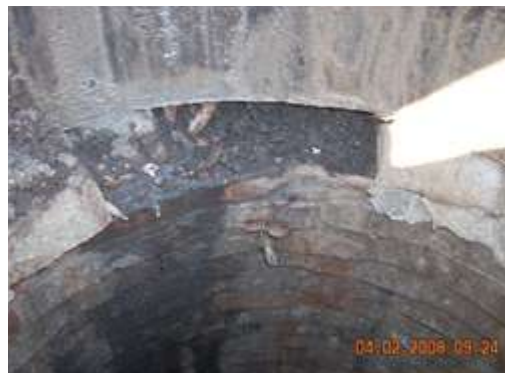
Defect 3

Condition: ☐ Sound ☐ Cracked ☐ Root Intrusion ☐ Loose Brick ☒ **Deteriorated**

deteriorated chimney

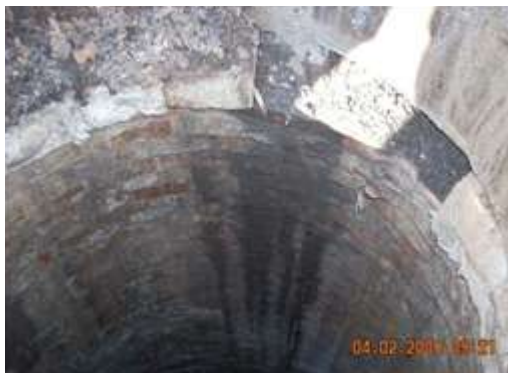
Defect 2

Infiltration: ☐ None ☒ **Joint** ☐ Cracks ☐ Mortar ☐ Roots ☐ Wall

infiltration @ chimney joint

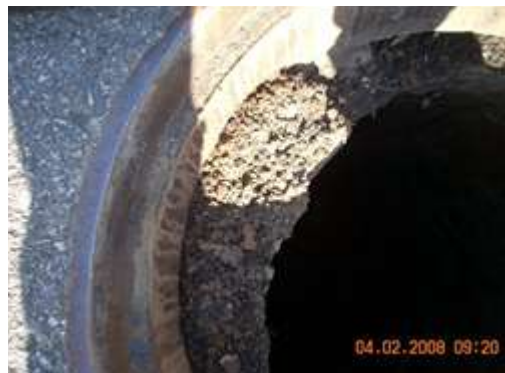
Defect 1

Offset: **4** (in.)

frame offset

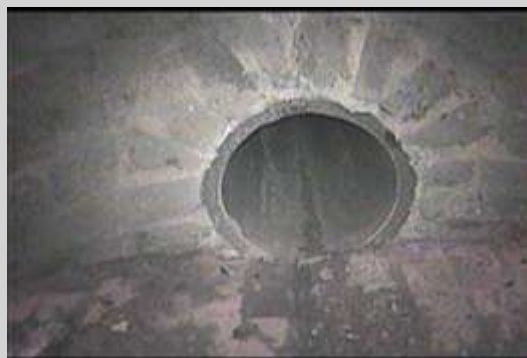
12 O'Clock Outflow

8 in. Circular Gravity Sewer
Pipe Out @ 12 O'Clock
